Escalator Safety for Owners: New Responsibilities

Outlining the rationale and steps for mandatory daily startup procedures

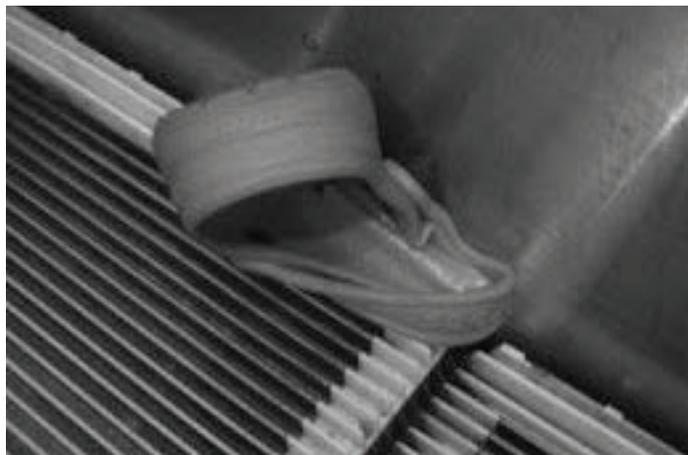
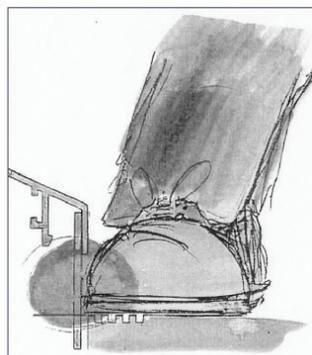
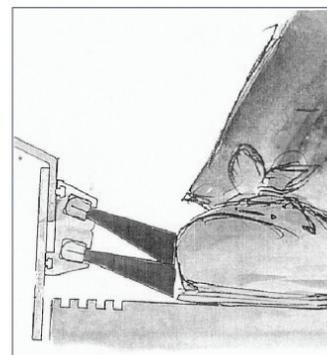
Ensure that the gap between the steps and skirt panels is within allowable limits. A17.1/B44 prescribes that step-to-skirt clearance shall be a maximum of 4 mm (0.16 in.) and that the sum of the clearance on both sides shall not exceed 7 mm (0.28 in.). It should be noted that different clearance limits may be allowed depending on the code in effect on the date of installation. Keep riders a safe distance from the gap by installing and maintaining skirt brushes/deflector devices.

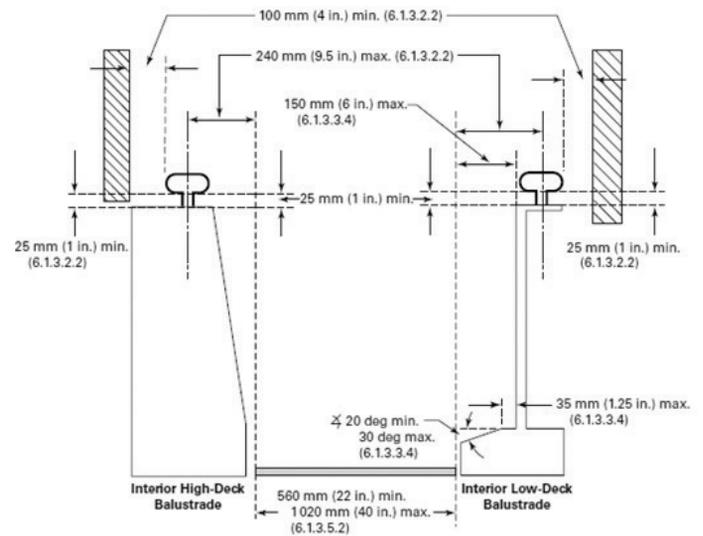
Ensure that the step-to-skirt clearance is within code requirements and that steps move freely adjacent to the skirt. Skirt panels need some rigidity with a surface finish that is smooth and relatively slippery. To quantify the skirt-to-step gap and the skirt

panels' overall smoothness and slipperiness, use the skirt/step performance index (SSPI), which is a calculation involving the friction between moving steps and stationary skirt panels. Owners should ensure that escalator maintenance contractors perform an SSPI test annually and keep results available for inspectors. To meet code requirements, it may be necessary to repair or upgrade existing escalator skirt panels. Installation of skirt brushes may be required if there is no step or skirt deflector.

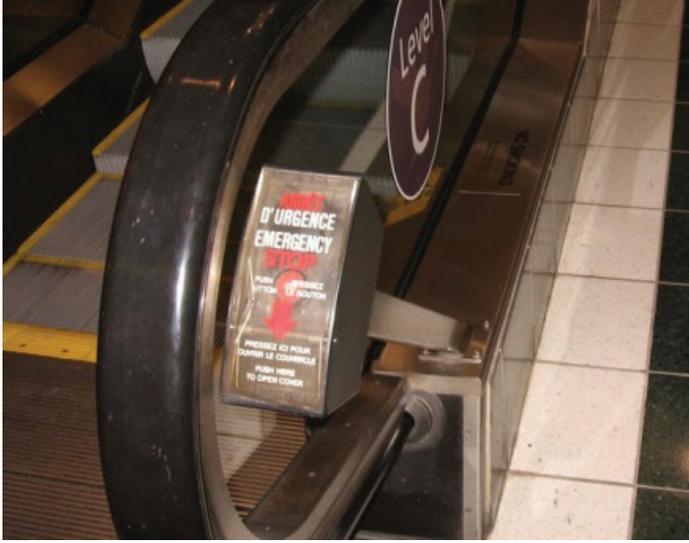
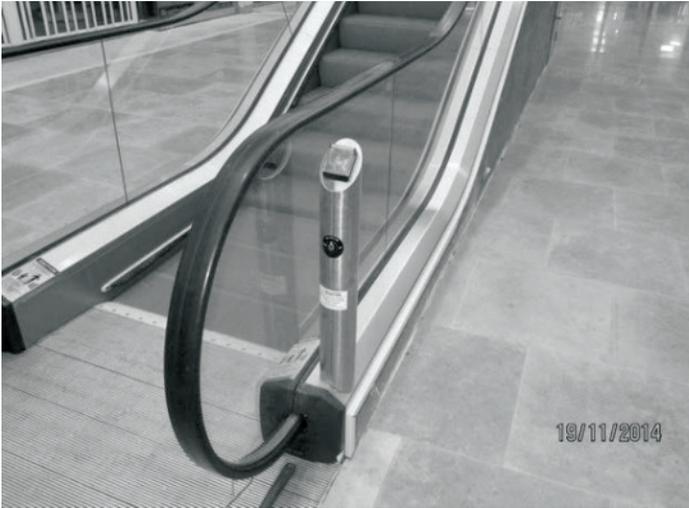
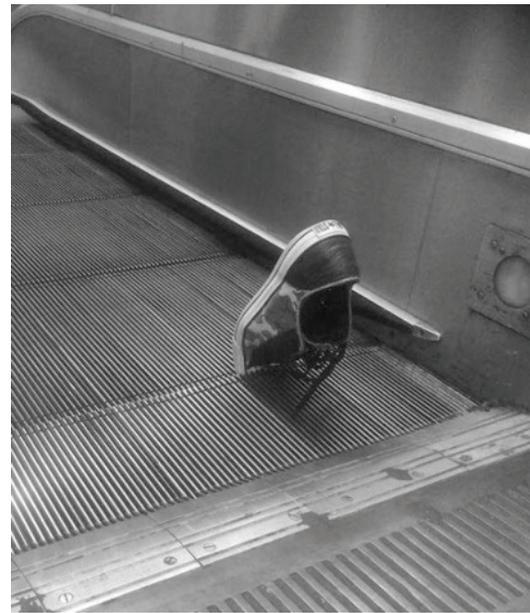
the top and bottom of the flight. If an object approaches the handrail entry or becomes caught between the handrail and entry portal, the safety switch will actuate to stop the escalator. The function of the handrail-

entry safety switch should be verified by pressing the protective cover and confirming the escalator stops.

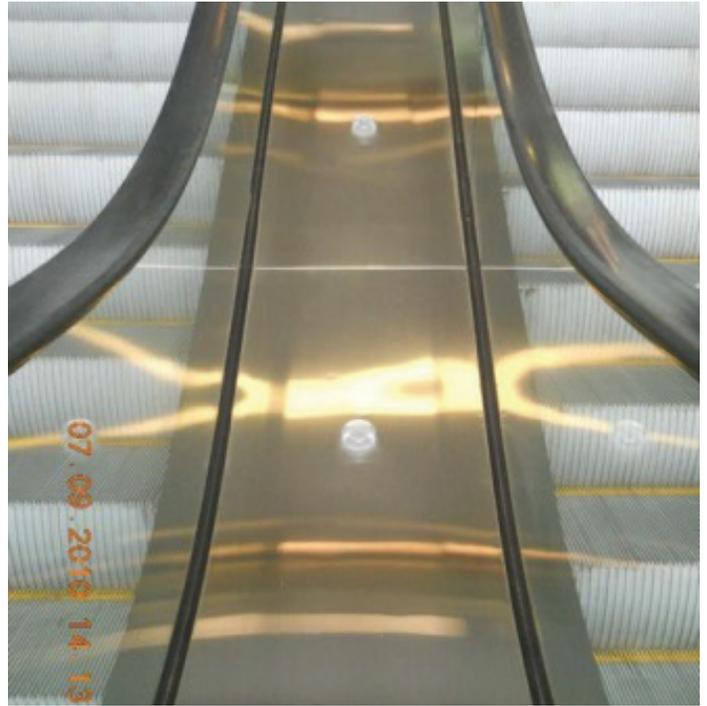
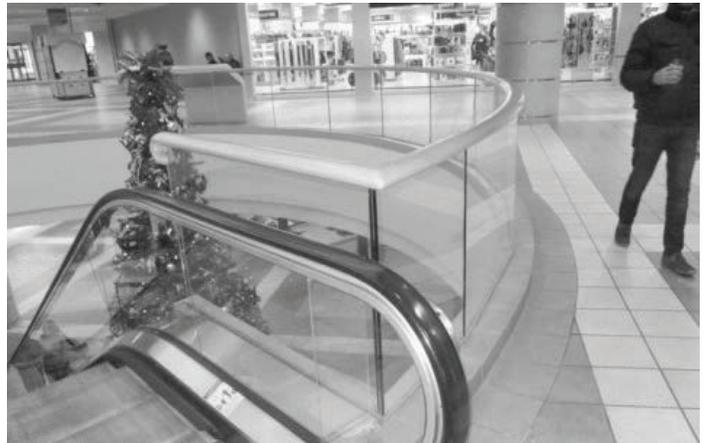
Inadequate illumination at the entry and exit safety zones could result in a rider not being able to clearly judge necessary footing while boarding or disembarking the escalator. Any anomaly in the landing-platform area, which might result in a slip or trip hazard, may not be easily discernable without proper illumination. For passengers to step safely onto escalators, the landing floor plates

and step band must be adequately lit. According to A17.1/B44, floor-level illumination at the top and bottom landing areas must be at least 50 lux.
